## QSFP Stacked Double Density Connector and Cage Assembly

Testing was performed on the TE connectivity (TE) QSFP Stacked Double Density Connector and Cage Assemblies to determine their conformance to the requirements of Product Specification 108-60130 Revision A.

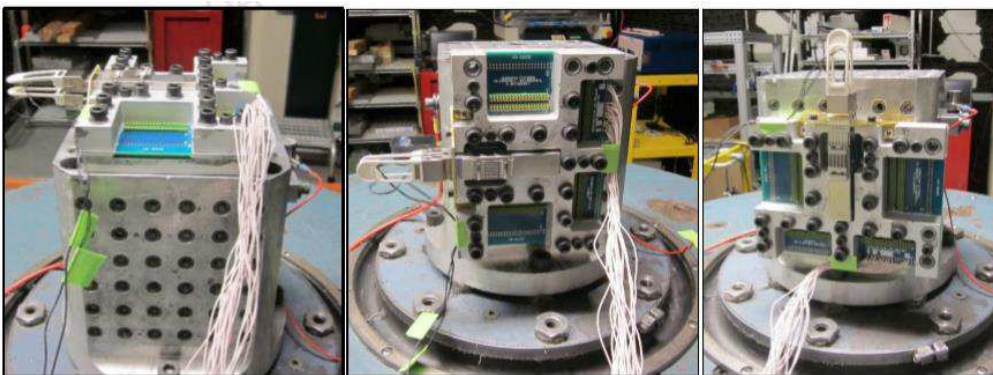
The test specimens were subjected to a mechanical shock test in accordance with specification EIA-364-27C, test condition A. The parameters of this test condition are a half-sine waveform with an acceleration amplitude of 50 gravity units (g's peak) and a duration of 11 milliseconds. Three shocks in each direction were applied along the three mutually perpendicular axes of the test specimens, for a total of eighteen shocks. The test specimens were monitored for discontinuities of 1 microsecond or greater using an energizing current of 100 milliamperes. Refer to Figure 4 for images of the typical mechanical shock test setup.

**Figure 4 - Typical Mechanical Shock Test Setup**

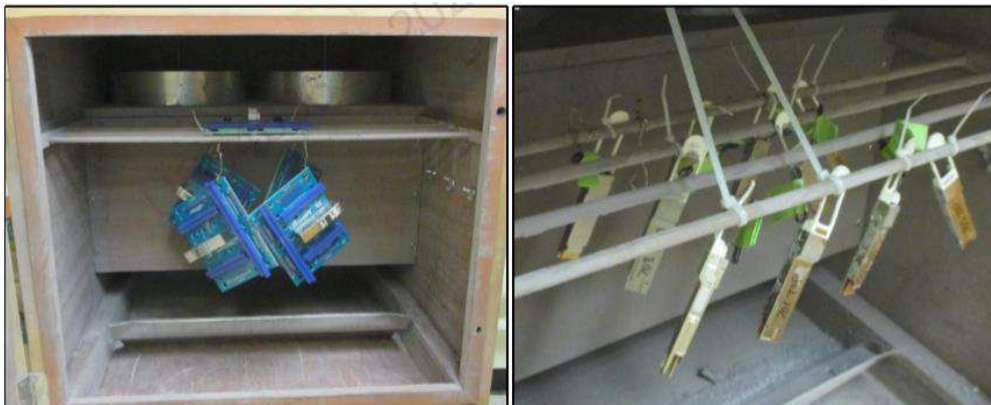
Prior to exposure, the dust composition #1 (Benign) was placed in a container and evenly spread. The dust was placed in a heated desiccator and dried at 50°C for 1 hour. A dust mass of 9 grams per cubic foot of chamber volume or a total of 125 grams was used. Unmated specimens were placed in the dust chamber at various orientations as shown in Figure 5. The chamber had an air flow rate of 1000 ft/minute. The specimens were exposed for 1 hour. Following the exposure, the specimens remained in the chamber for an additional hour. Each specimen was tapped 5 times for removal of excess dust. Testing was performed in accordance with EIA-364-91B.

**Figure 5 - Typical Benign Dust Contamination Test Setup**

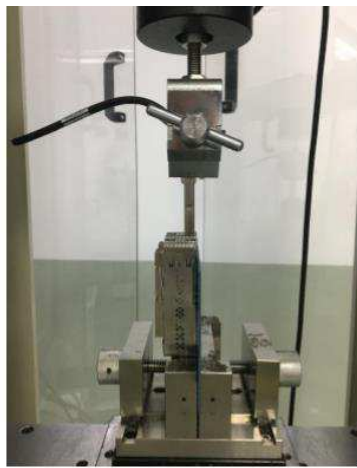
The force required to insert the transceiver into the receptacle with kick-out springs inoperable was measured using a tensile/compression device with a free-floating fixture and a rate of travel of 12.7 mm [.5 in] per minute. Figure 6

Test setup (mating force)

**Figure 6 – typical transceiver mating/unmating test set up**

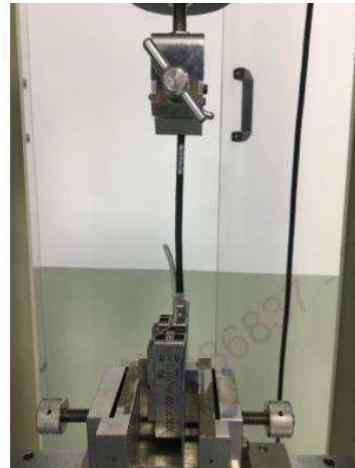
The force required to extract the transceiver from the receptacle with kick-out springs inoperable was measured using a tensile/compression device with a free-floating fixture and a maximum rate of travel of 12.7 mm [.5 in] per minute. Figure 6

Test setup (un-mating force)

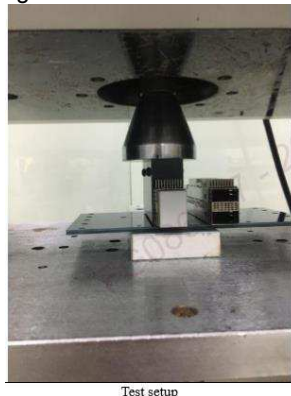
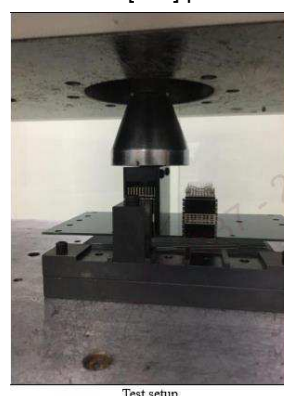
The force required to insert the specimen onto the PCB into proper seating location was measured using a tensile/compression device with a free-floating fixture with seating tool at a maximum rate of travel of 12.7 mm [.5 in] per minute. Figure 7.

The force required to extract the specimen from the PCB was measured using a tensile/compression device with a free-floating fixture with extracting tool at a maximum rate of travel of 12.7 mm [.5in] per minute. Figure 7.

**Figure - 7 typical press-fit insertion/retention test setup**
